METALS HANDBOOK

VOL. 9
FRACTOGRAPHY AND ATLAS OF FRACTOGRAPHY

8th EDITION

Fractography and Atlas of Fractographs

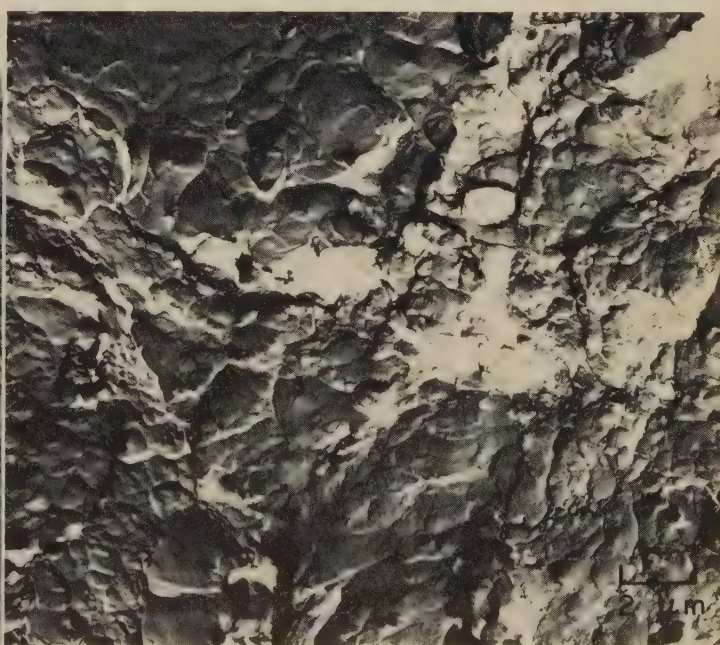
4372 TEM replica of the tension-overload fracture surface in 4369, showing an area that is only slightly above and to the left of the area seen in fractograph 4370. The two dark marks visible at bottom left cannot be positively identified, but they may be indications of secondary cracks.

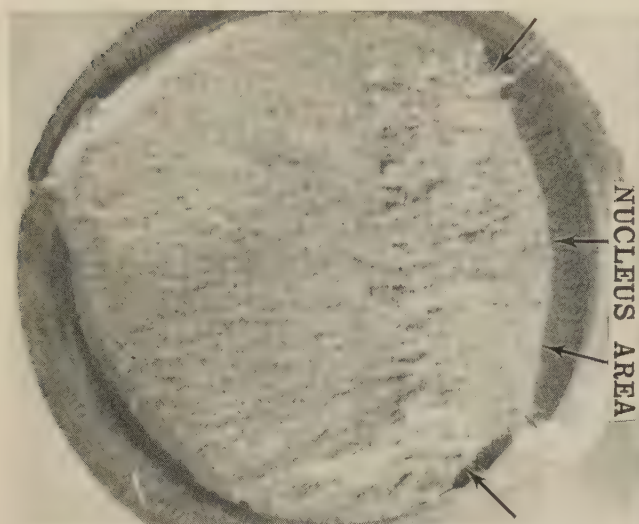
Light fractograph 12×
4373 Surface of a fracture in a specimen of D-6ac steel that broke during a stress-corrosion-cracking test in deionized water. Stress-corrosion cracking originated at the root of a dark heat-treat crack in a thread at right; fast fracture occurred after only 15 hr at a tension of 814 MPa (118 ksi). See also fractograph 4374.

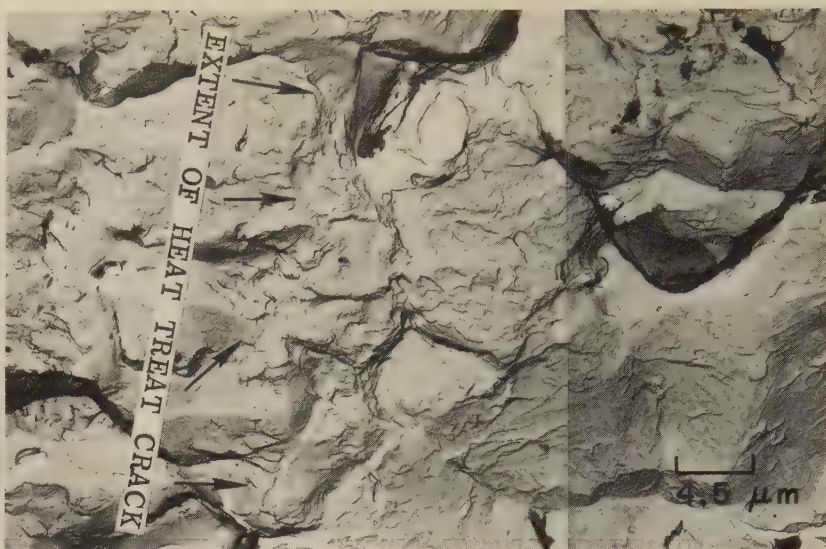
TEM fractograph (p-c replica) 2200×
4374 TEM replica of an area of the fracture surface in 4373 containing the boundary (indicated by arrows) between the heat treatment crack (left) and the stress-corrosion crack (right). At right are intergranular facets, which resulted from stress-corrosion cracking; essentially no corrosion products were formed on these facets during this brief test.

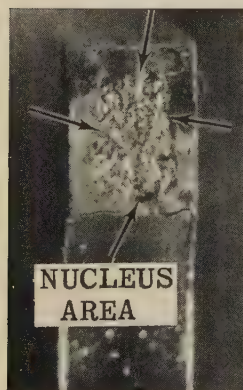
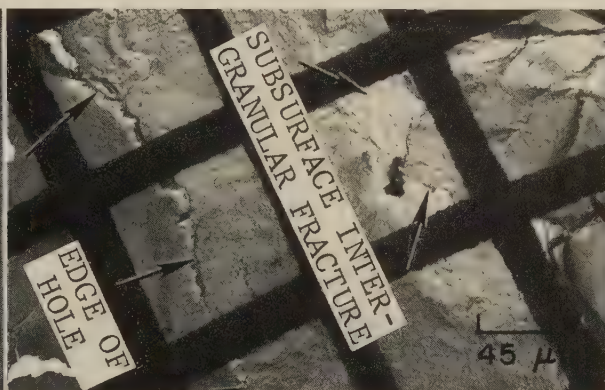
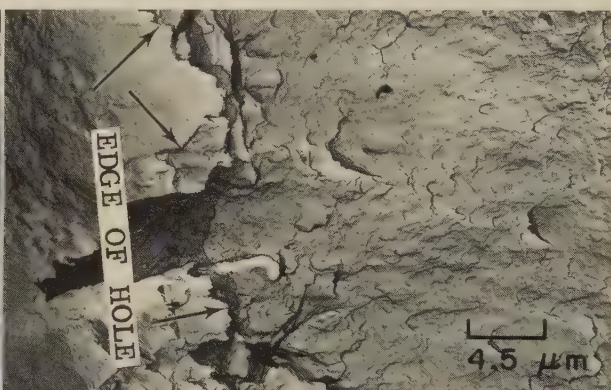
Light fractograph 14× TEM fractograph (p-c replica) 220× TEM fractograph (p-c replica) 2200×
4375, 4376, 4377 Surface of a fracture in a tension-loaded specimen of hydrogen-embrittled 300M steel heat treated 1 hr at 871 C (1600 F) and oil quenched, then double tempered 2 hr plus 2 hr at 302 C (575 F) and air cooled. Tensile strength was 1979 MPa (287 ksi). The nucleus of the crack was below the specimen surface (as indicated in 4375, at left), near a hole with a radius of 0.063 in., which acted as a notch. Fractograph 4376 (center) is a low-magnification TEM view, through a supporting grid, of the edge of the hole and the origins of the subsurface crack, which is intergranular. Fractograph 4377 (right) is a higher-magnification TEM view of the edge of the hole and shows the very flat tear dimples that formed between the crack origins and the hole. See also 4378, below.

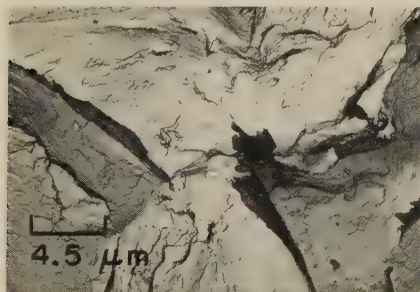
TEM fractograph (p-c replica) 2200×
4378 TEM view of the nucleus of the subsurface crack that led to the fracture in 300M steel shown in 4375 to 4377. Separated-grain facets and hairline indications, both of which are typical of hydrogen embrittlement, are clearly evident.

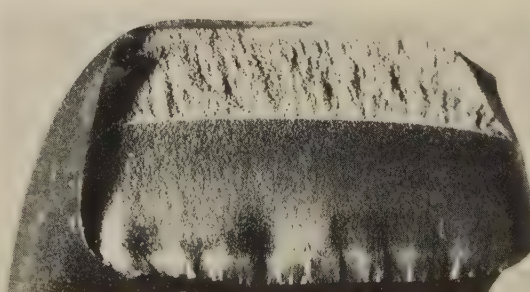
Light fractograph 5×
4379 Surface of a fatigue fracture in a transducer spring made of 1080 steel. The dark zone at bottom is the region of fatigue fracture, and the light zone at top is the region of final, fast fracture. "Ratchet" marks along the lower edge of the fatigue-fracture zone indicate that this fracture had a large number of nuclei. See 4380.

TEM fractograph (p-c replica) 10,000×
4380 High-magnification TEM view of the fatigue zone (dark, at bottom) of the fracture surface in 4379, showing fatigue striations. The fatigue striations are irregular and quite flat, which explains the smooth appearance of this zone in fractograph 4379.

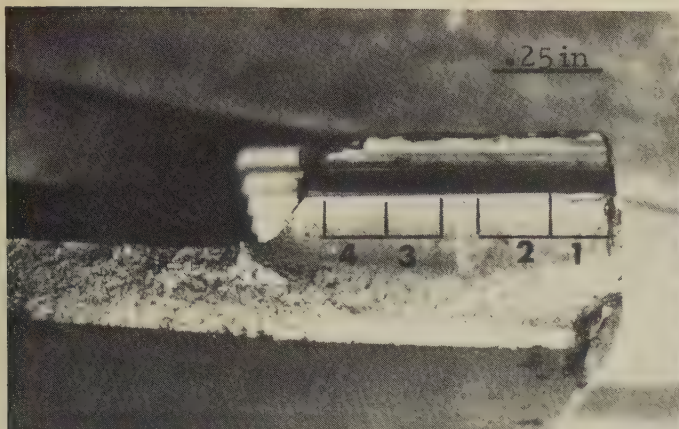
Light fractograph

4381 Surface of a fatigue fracture, which originated at the root of a tooth, in a ring gear of Nitralloy G steel. Fracture occurred at full load in service after 2 hr of run-in. Hardness was Rockwell C 34 in the core and greater than Rockwell C 60 in the case. At the crack origin, effective case depth was 30% below specification. See also 4382.

4382 TEM replica of the fracture surface in 4381, showing an area in region 1, which is below the tooth root (fracture origin). This area, from the core of the gear, shows high-cycle fatigue striations (diagonal marks) and is typical of most of the fracture surface. The fracture resulted from inadequate fatigue strength of the thin case at the origin.

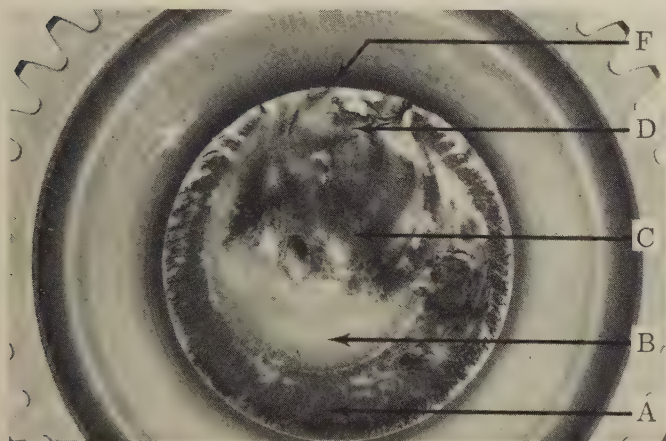
Light fractograph

4383 Fatigue fracture in a turbine planet gear of 9310 steel that broke under a light load in service (during run-in). The gear had been heat treated to a hardness of Rockwell C 36.5 to 40 (near the surface). See also 4384 to 4386.

4384 TEM replica of area A in the outer region of the fracture surface in 4383, showing separated-grain facets. This region is believed to have formed a heat-treat crack—the only plausible explanation of its intergranular nature.

4385 TEM replica of an area representative of fatigue regions B and C in the fracture surface in 4383 (above), between the outer, intergranular zone and the inner, fast-fracture zone, showing striations, formed by torsional stresses during run-in, that are normal to the perimeter of the gear.

4386 TEM replica representative of areas D and F in the inner, fast-fracture zone in 4383. The numerous equiaxed dimples here indicate that fast fracture resulted from microvoid coalescence under tension overload; termination of fast fracture formed shear dimples (at upper left).

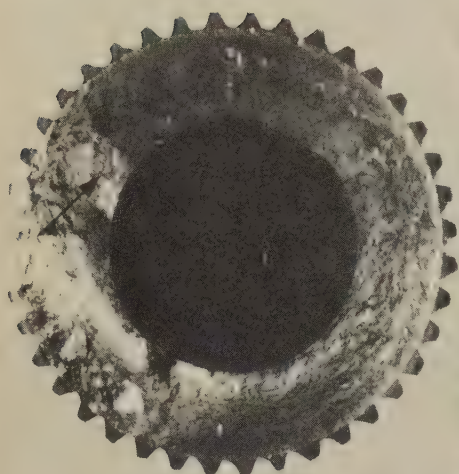
4387, 4388

Fractograph 4387 (left) shows a fracture surface of a carrier planet gear made of ductile iron (hardness, 146 to 183 Bhn). The gear fractured in service less than 10 hr after installation. Fractograph 4388 (right) is a TEM view of a plastic-carbon replica of the area at the arrow in 4387; the elongated dimples indicate that the gear fractured by torsion overload. Because the mechanical properties of the iron were acceptable, the fracture was attributed to improper installation.

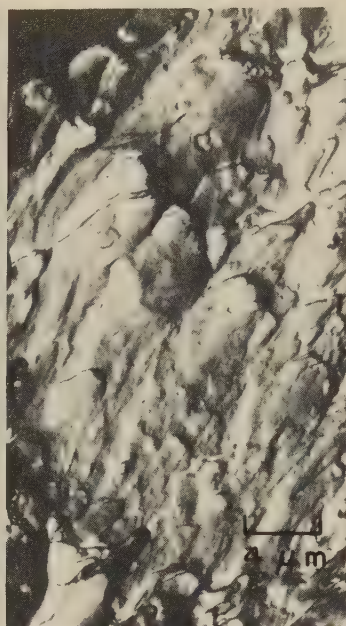
4389, 4390 At left, light fractograph 4389 shows a corrosion-fatigue fracture surface in 18Ni-9Co-5Mo maraging steel with a tensile strength of 2068 MPa (300 ksi), tested in tap water at 1000 cycles per minute to a stress of 862 MPa (125 ksi) max, 172 MPa (25 ksi) min. The maximum load was held 4 hr after each 1000 cycles. At right, TEM fractograph 4390 shows a plastic-carbon replica of a region in the area at A in 4389, which exhibits fatigue striations and corrosion. See 4391 to 4395, below.

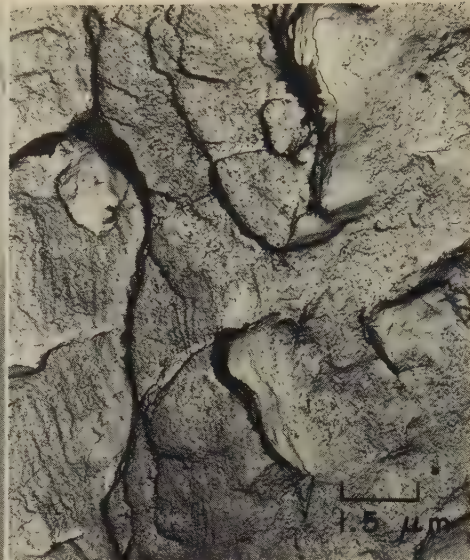
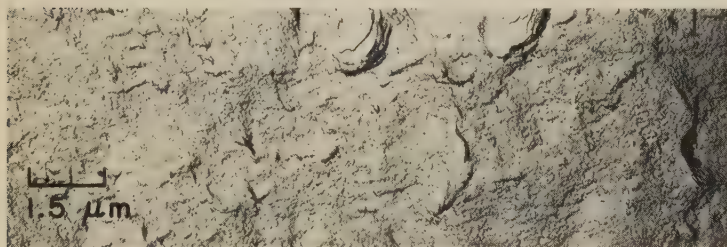
TEM fractograph (p-c replica)

4391 A TEM view of a second region in area at A in fractograph 4389, showing fatigue striations that were very nearly corroded away by the tap water used in the fatigue test. At scattered spots there are suggestions of incomplete dimples.

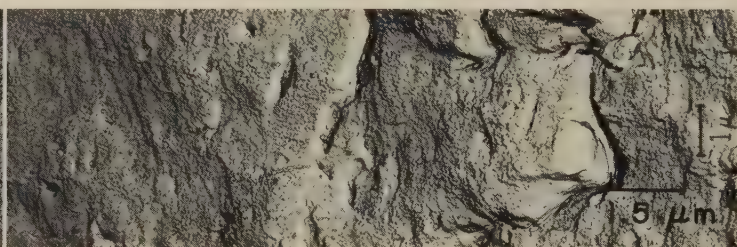
TEM fractograph (p-c replica)

4392 A TEM view of a third region in area at A in fractograph 4389. Here, corrosion has removed nearly all traces of fatigue striations, except for a few scattered marks. There appear to be indications of secondary cracks in grain boundaries.

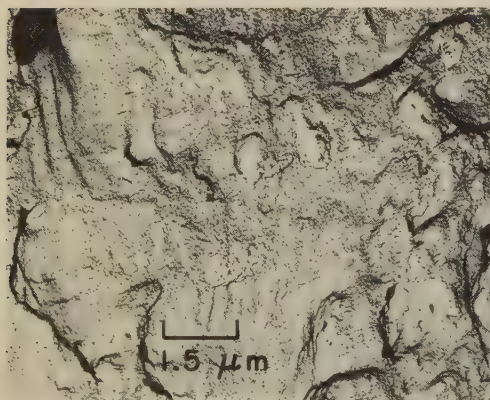
TEM fractograph (p-c replica)

4393 A TEM view of a fourth region in area at A in 4389, showing fatigue striations somewhat more widely spaced than in 4390—the result of an increase in stress as the crack deepened.

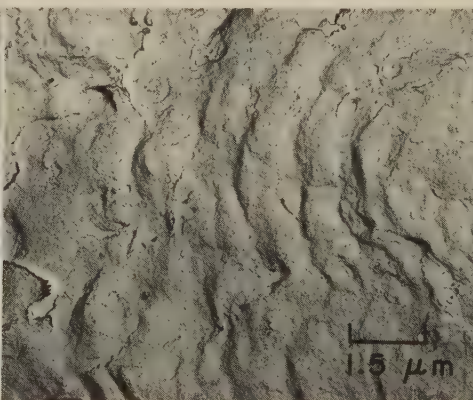
TEM fractograph (p-c replica)

4394 A TEM view of a fifth region in the area at A in fractograph 4389, displaying quite widely spaced, irregular fatigue striations. These striations were evidently formed late in the fatigue test.

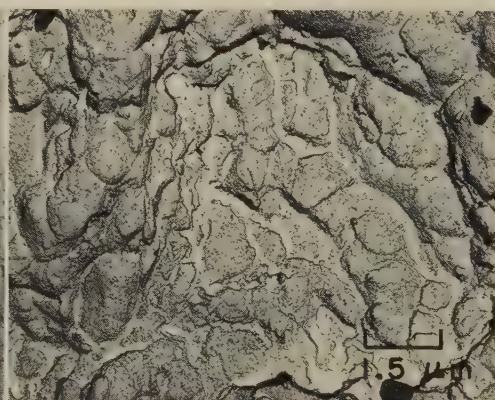
TEM fractograph (p-c replica)

4395 A TEM view of the area at B in 4389. This area was formed by fast fracture resulting from a planned increase in load after the fatigue test was stopped; it shows the expected dimples.

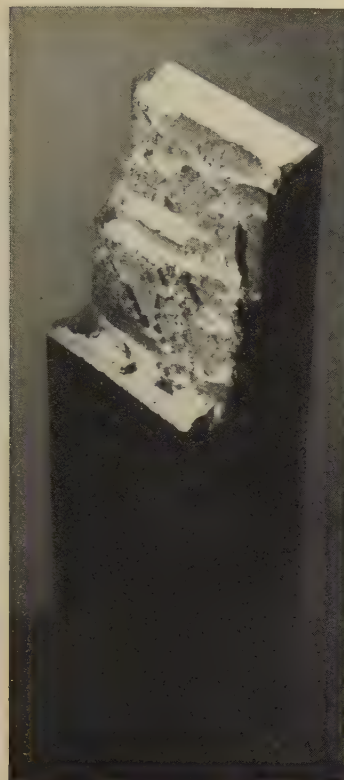
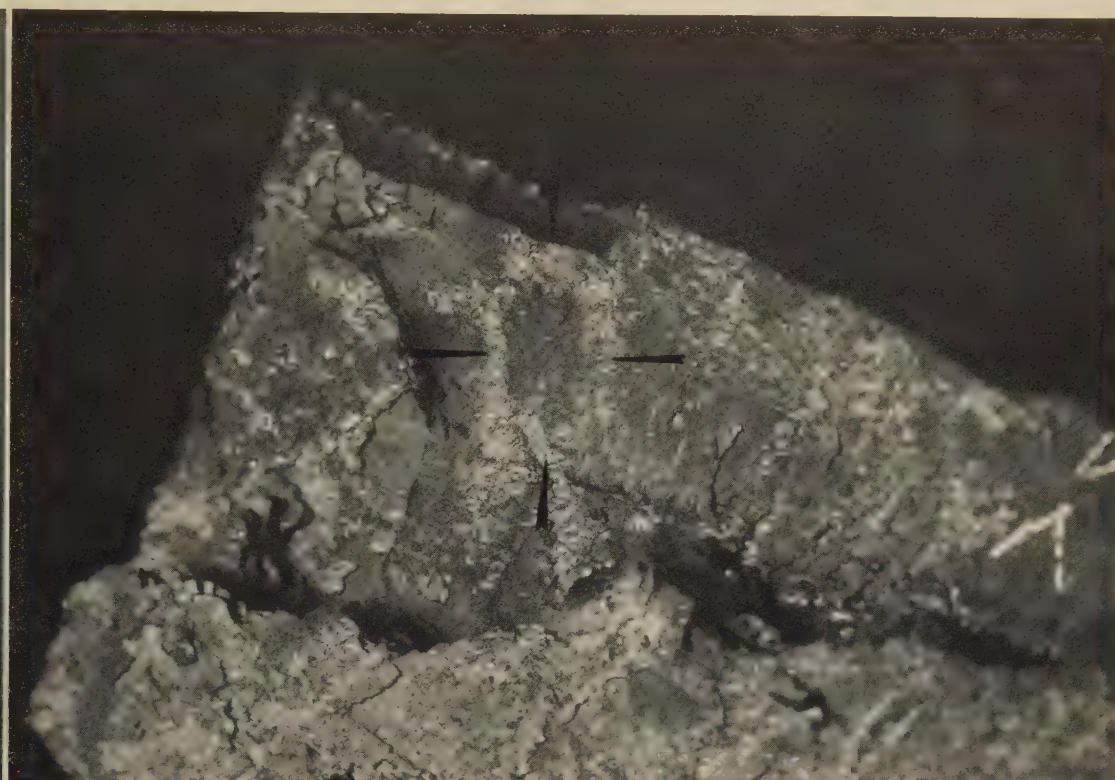
Light fractograph
4396, 4397

At left (4396) is a slow-bend fracture of a weld specimen made by gas tungsten-arc butt welding two $\frac{3}{4}$ -in.-thick plates of 18% Ni maraging steel having a yield strength of 1724 MPa (250 ksi). A specimen $\frac{3}{4}$ in. square by 7 in. long was cut across the weld. After the weld was ground flush, the specimen was notched and then fatigue-cracked in the center of the weld and parallel to the length of the weld. After being aged at 490 C (914 F), the specimen was broken at room temperature in slow, three-point bending. Fracture surface shows steps caused by splitting. A portion of one of these steps is shown at higher magnification in fractograph 4397 (right); the surface here exhibits a network of high-reflectivity areas, one example being identified by the arrows. The remaining areas of the surface were relatively dull. Also see fractographs 4398 to 4401 (below).

Fractographs 4398 and 4399 (left, and left center) are TEM views, at different magnifications, taken from one of the high-reflectivity areas in fractograph 4397. The shiny aspect was due to flat platelets resulting from cleavage of particles of unidentified composition. Note that in both views there are tear dimples between the reflecting facets. Fractograph 4400 (right center) reveals that the structure in the low-reflectivity areas in this fracture surface consists of rather flat equiaxed dimples. Fractograph 4401 (right) is from a companion 18% Ni maraging steel weld specimen to the one in 4396-4400; specimen here was hydrogen embrittled and then fractured by sustained loading at room temperature. This fracture surface shows dimples, together with quasicleavage facets that contain characteristic steps, river patterns and tear ridges.

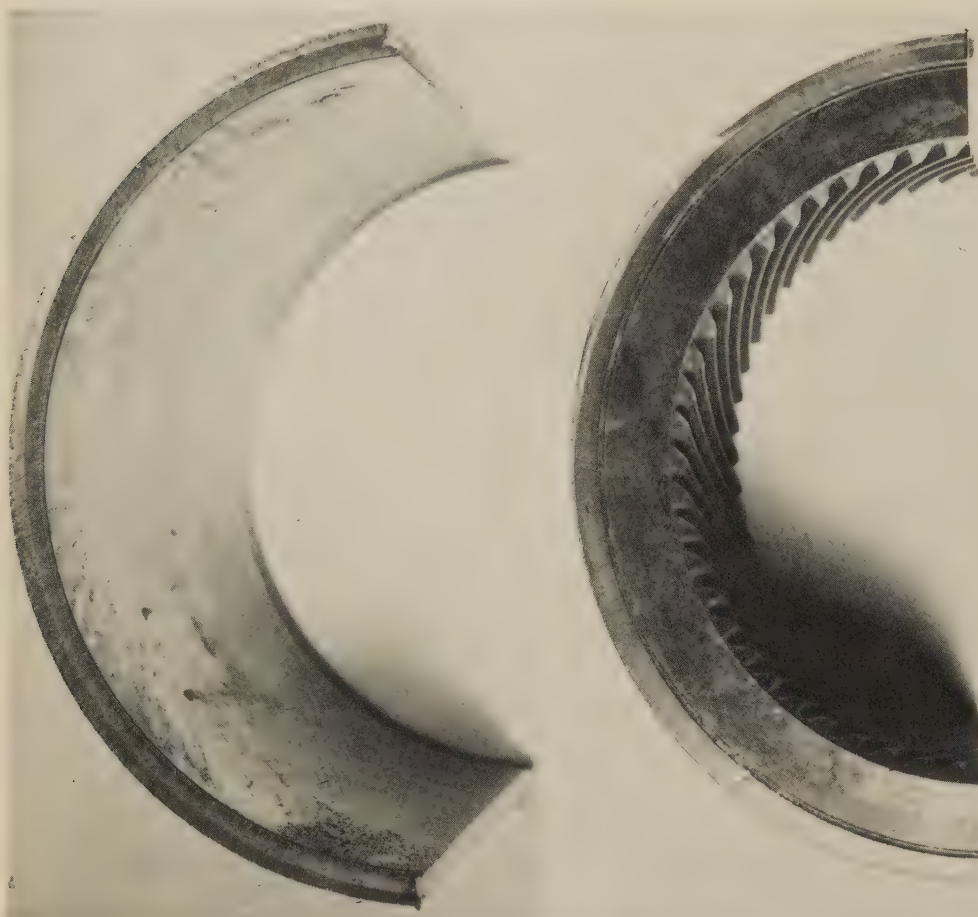
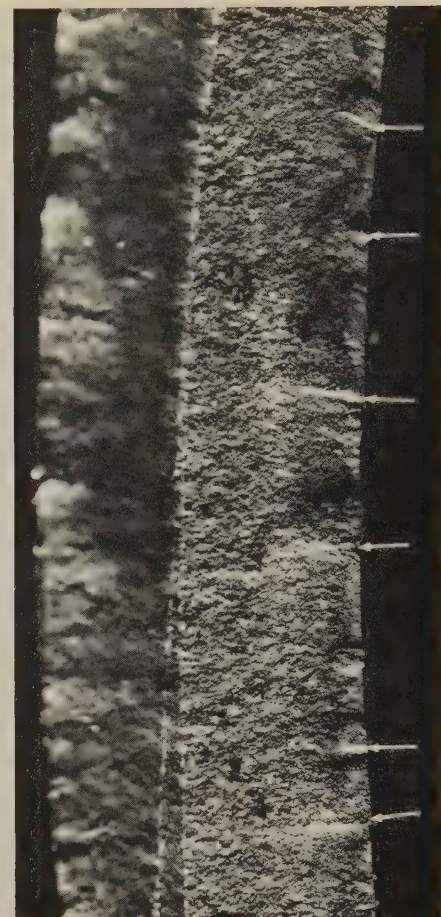
4402, 4403, 4404

Photographs 4402 (left) and 4403 (center) show the mating segments of a fractured type 501 stainless steel torque cylinder from the hub socket of an aircraft propeller. Cracking originated at an internal fillet at a shoulder between the smooth bore (4402) and the internal spline (4403). Fractograph 4404 (right) shows clearly the inner fatigue zone and the outer zone of final, tensile-shear fracture. The ratchet marks visible in 4402 (at the bore) are shown more clearly in 4404, a view that reveals many crack nuclei (at arrows). The fatigue cracks that propagated from these nuclei ultimately merged to form a common front. See also fractographs 4405 and 4406 (below), and 4407 and 4408 (opposite page), for TEM views of other regions of this fracture surface.

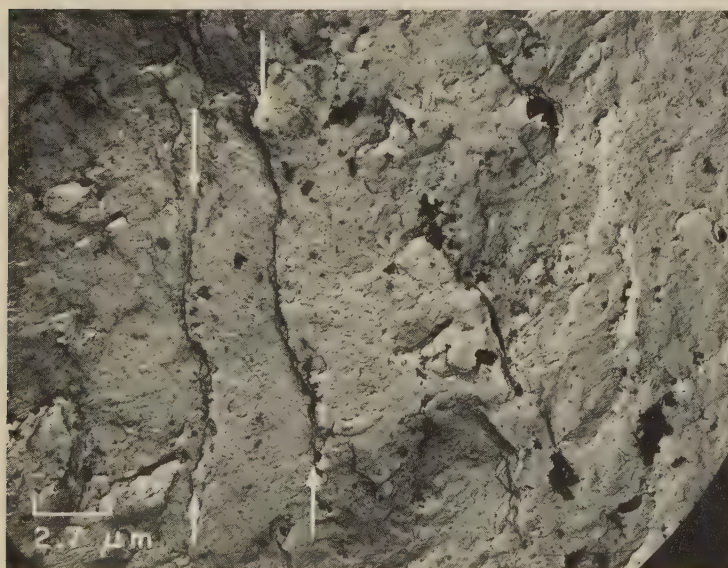
4405 TEM replica of the fracture surface in 4402, showing a region about 30 μm from a crack nucleus. Visible between the arrows are steps that separate fatigue patches. Fatigue striations are faintly visible within the patches.

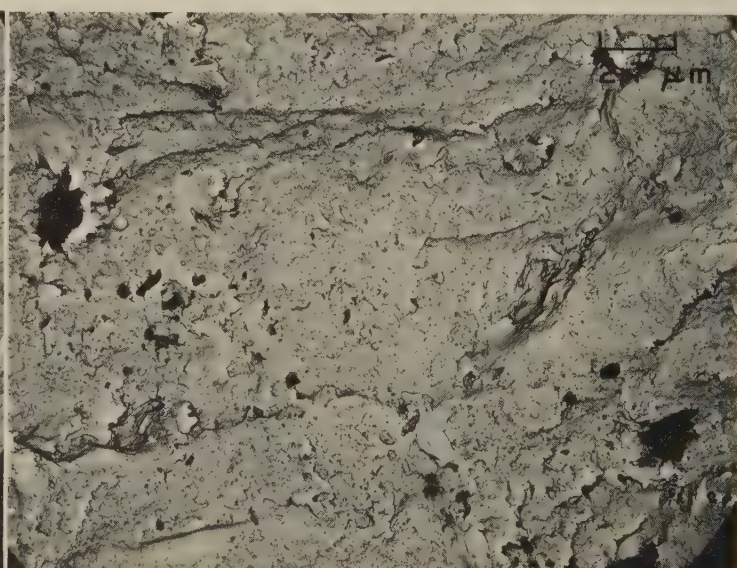
4406 TEM replica of the fracture surface in 4403, showing a region about 30 μm from the inner edge. This view shows generally flat fatigue patches that are separated by steps, but no fatigue striations are visible within the patches.

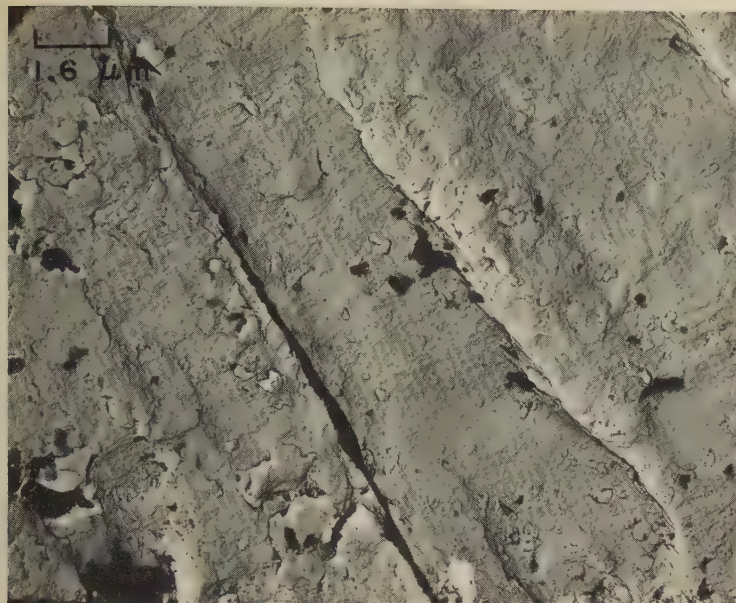
TEM fractograph (p-c replica)

4407 TEM replica of the fracture surface in 4402, showing a region in the fatigue zone but near the zone of final, tensile-shear fracture. This replica reveals fatigue patches separated by steps and containing faint fatigue striations.

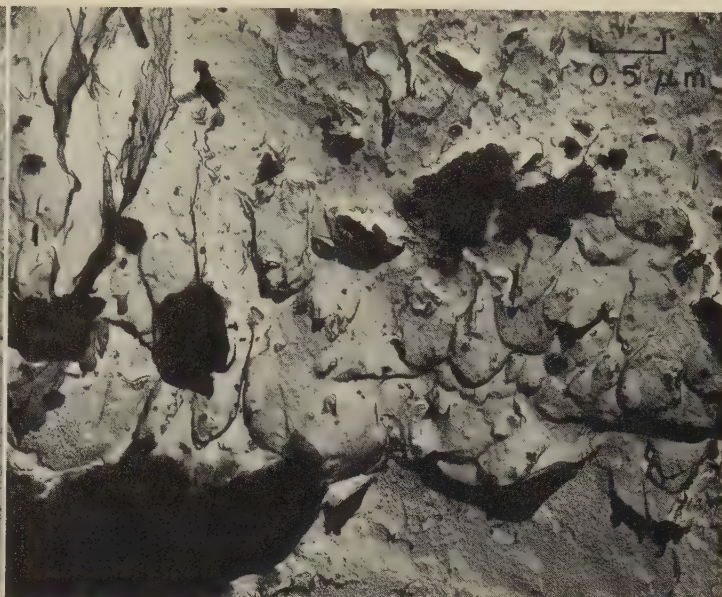
TEM fractograph (p-c replica)

4408 TEM replica of a portion of the shear lip in the fracture surface in 4402, showing shear dimples, which resulted when microvoid coalescence occurred during final, tensile-shear fracture. The dark areas are probably rust or "dirt".

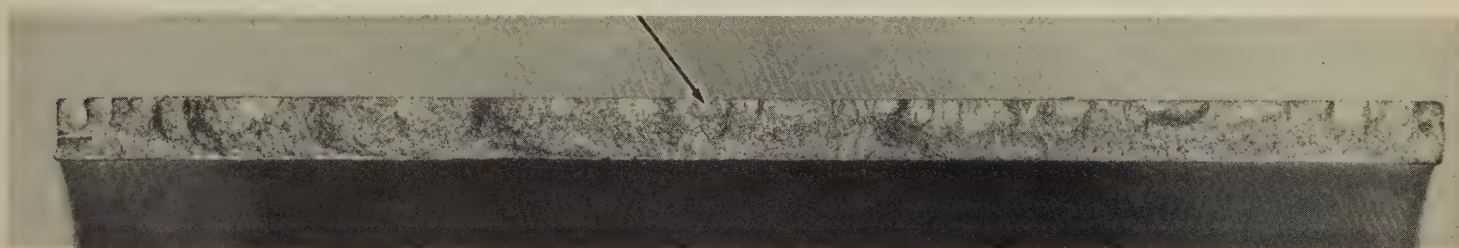
Light fractograph

4409 Fracture in a hydrogen-embrittled specimen of H11 tool steel air cooled from 1010 C (1850 F), tempered at 538 C (1000 F), and cathodically charged with hydrogen for 45 min at 1 amp per square inch. The specimen was a hoop with 2-in. ID, 0.050 in. thick and 1 in. long. Fracture occurred during application of static load. See 4410 and 4411 for TEM views of regions at arrow.

4410 TEM replica of a region at the arrow in 4409, showing the predominantly intergranular fracture surface that is associated with hydrogen embrittlement.

4411 TEM replica of another region at the arrow in 4409, showing an intergranular surface similar to 4410. The grain facets in both 4410 and 4411 are quite free of corrosion products.

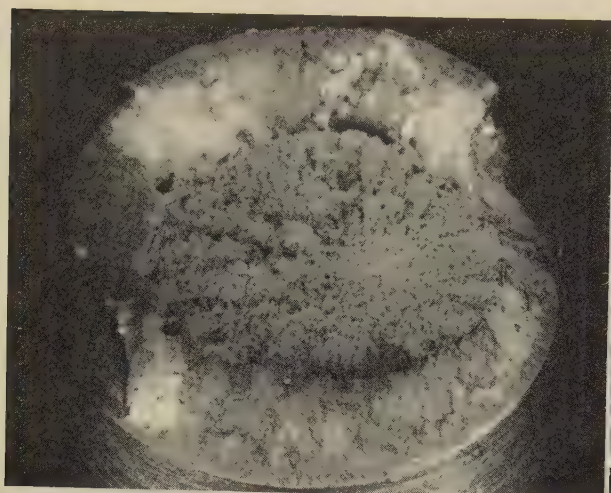
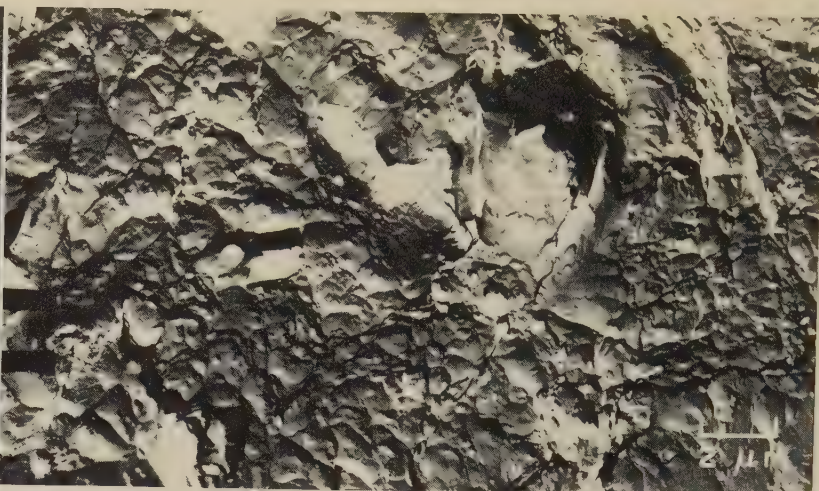
4412, 4413 Fractograph 4412 (left) shows the surface of a cup-and-cone fracture in an unnotched specimen of H11 tool steel that was heat treated to a tensile strength of 2041 MPa (296 ksi) and broken in tension overload. The fracture originated in the small, central fibrous area contained in the annular radial fibrous zone, and ended at the shear lip. Fractograph 4413 (right) is a TEM replica of an area near the origin of the fracture shown in 4412, exhibiting rather uniformly small, equiaxed dimples surrounding a deep cavity (at right of and above center).

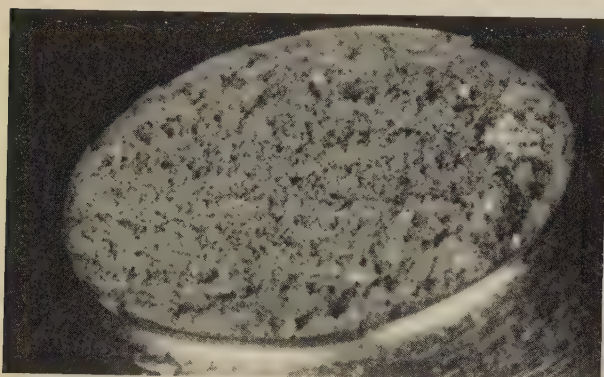
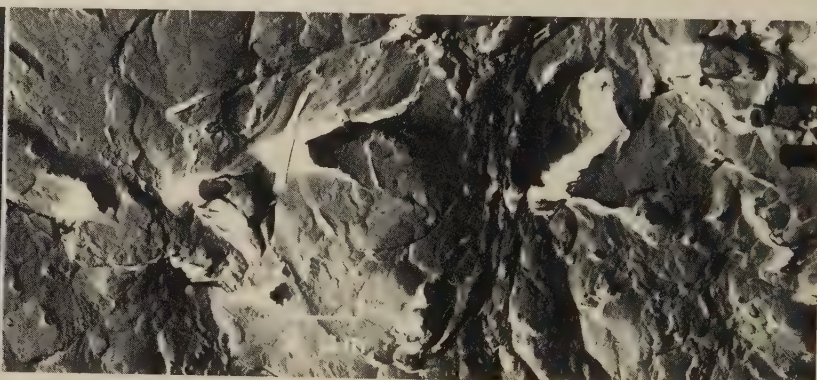
4414, 4415 Fractograph 4414 (left) shows the surface of a fracture in a notched specimen of H11 tool steel that was broken in tension overload. Unnotched tensile strength was the same as that of the specimen in 4412; notched tensile strength was 2665 MPa (386.5 ksi). Although the illumination here does not permit critical appraisal, the fracture surface appears to be flat and fibrous. Fractograph 4415 (right) is a TEM replica of a region of the fracture surface in 4414, showing many small and medium-size dimples. Also visible are large facets with characteristics that suggest local quasicleavage.

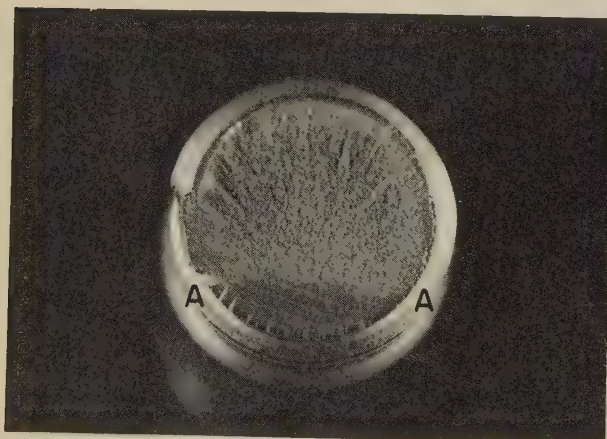
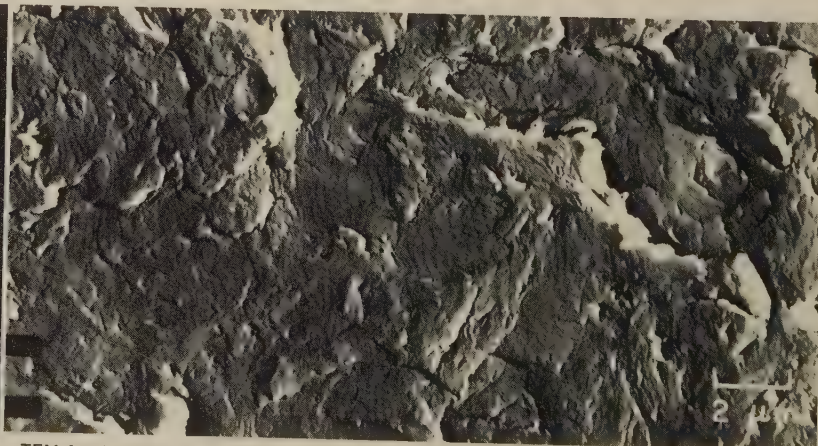
4416, 4417 Fractograph 4416 (left) shows the surface of a low-cycle fatigue fracture in a threaded specimen of H11 tool steel heat treated to the same tensile strength as the specimen in 4412 and loaded in tension-tension ($R = 0.1$); maximum stress was about 60% of tensile strength. Fracture occurred after 21,000 cycles. At bottom, cracks propagating from several origins merged to form a beach-mark crescent (A-A). Fractograph 4417 (right) is a TEM replica of an area within the beach-mark crescent in 4416. Fine fatigue striations are clearly visible and in general have approximately the same orientation. Several secondary cracks are evident as well.

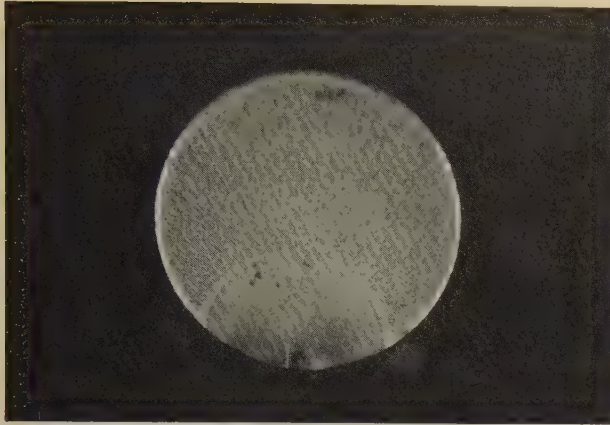
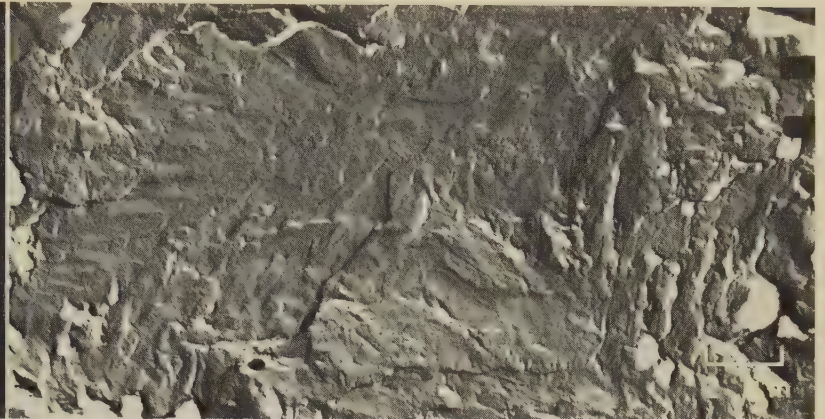
4418, 4419

Fractograph 4418 (left) shows the surface of a high-cycle fatigue fracture in a specimen of H11 tool steel (same tensile strength as that of the specimen in 4412, on the facing page) that broke after 775,000 cycles. The specimen was loaded in tension-tension ($R = 0.1$), with a maximum stress of about 30% of tensile strength. The beach-mark crescent is clearly evident at bottom. Fractograph 4419 (right) is a TEM replica of a region within the beach-mark crescent in 4418. This extremely smooth fracture surface, which shows little evidence of fatigue striations, suggests some form of cleavage.

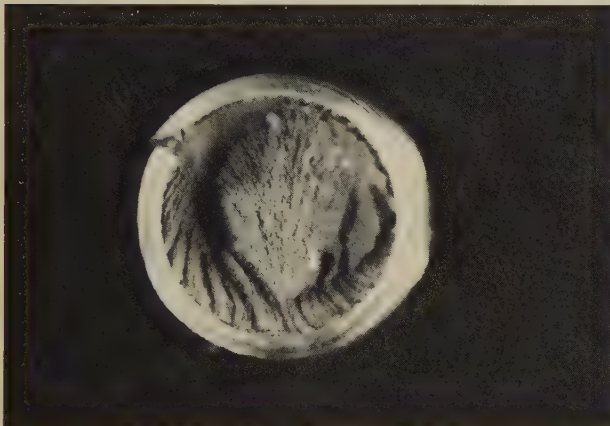
4420, 4421

Fractograph 4420 (left) shows the surface of a fracture in a threaded specimen of H11 tool steel (same tensile strength as in 4412) hydrogen embrittled as a result of electroplating. This fracture, which occurred during stressing to 75% of tensile strength, originated around nearly the entire circumference of the specimen and yielded a fibrous surface. Fractograph 4421 (right) is a TEM replica of a region of the surface in 4420, showing an array of many very fine dimples on separated-grain facets. At top center is a grain that appears to have been cleaved. There is very little evidence here of secondary intergranular cracking.

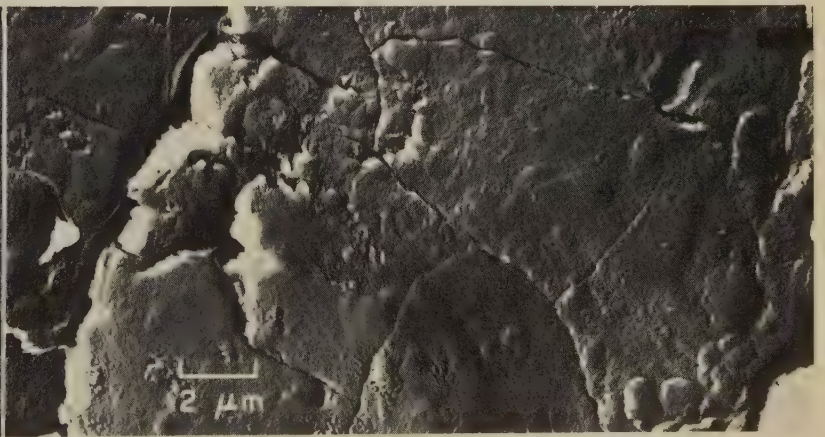
4422, 4423

Fractograph 4422 (left) shows the surface of a fracture resulting from stress-corrosion cracking in a threaded bolt of H11 tool steel (same tensile strength as in 4412) stressed to 75% of tensile strength while immersed in a solution of 3.5% NaCl in water. This fracture, which originated around more than 50% of the circumference of the specimen (portion at bottom and at right), yielded a fibrous surface. Fractograph 4423 (right) is a TEM replica of a region in the stress-corrosion portion of the fracture surface in 4422. The features revealed are separated-grain facets containing, in this particular area at least, comparatively little evidence of corrosion products. There are many secondary cracks within the grains and a few large secondary cracks between grains.

6× TEM fractograph (p-c replica)

5000×

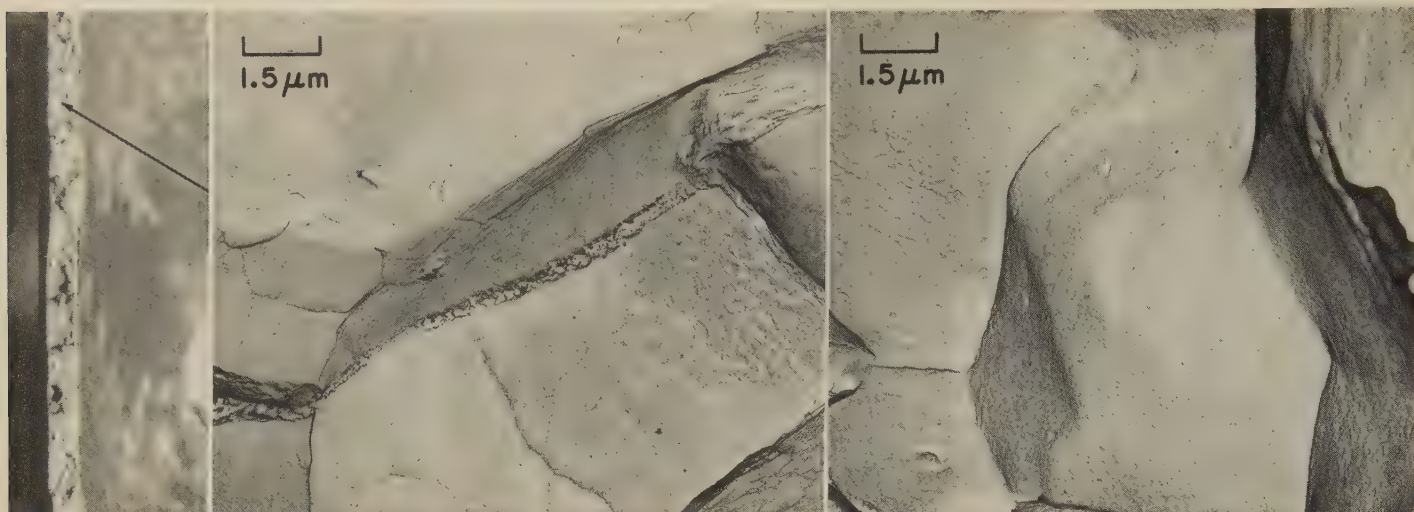
Light fractograph; two TEM fractographs (p-c replicas)

$3\frac{1}{8}\times$ (4424); $6500\times$ (4425, 4426)

4424, 4425, 4426 Fractograph 4424 (left) shows the surface of a fracture that resulted from stress-corrosion cracking in a hoop specimen of type 410 stainless steel air cooled from 982 C (1800 F) and tempered at 371 C (700 F). Tensile strength was 1241 to 1379 MPa (180 to 200 ksi). The specimen was exposed to a marine atmosphere while being stressed at 1055 MPa (153 ksi), and fracture occurred after 10½ months. Fractographs 4425 (center) and 4426 (right) are TEM replicas of two areas at the arrow in the fracture surface in 4424, showing intergranular rupture. In 4425 can be seen a modest amount of corrosion products and some hairline indications that are characteristic of either stress-corrosion cracking or hydrogen embrittlement. In 4426, there are remarkably few features other than separated-grain facets. The lack of considerable corrosion products in 4425 and 4426 after the long marine exposure reflects the slow rate at which this alloy is corrosively attacked. See also 4427.

4427 TEM replica of another area at the arrow in the fracture surface shown in 4424. Here, as in 4425 and 4426, very few traces of corrosion products are evident. Note the extreme smoothness of the facets.

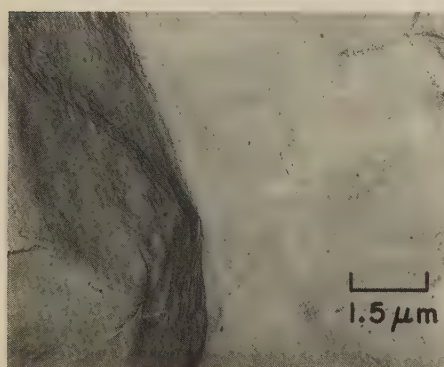
TEM fractograph (p-c replica) $6500\times$

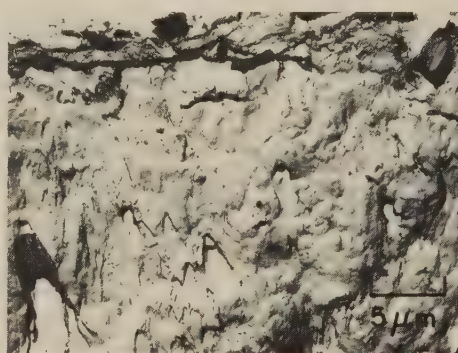
TEM fractograph (direct carbon replica) $2000\times$

4428 Fracture surface of ¼-in.-diam wire, of type 410 stainless steel austenitized ½ hr at 954 C (1750 F), air cooled, and tempered 2 hr at 510 C (950 F), that broke at a notch. Conical dimples at center point toward notch (at top), which shows wavy file marks. See 4429 to 4432.

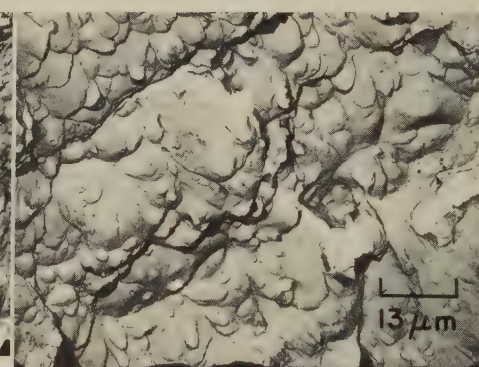
TEM fractograph (direct carbon replica) $750\times$

4429 Another replica of the fracture surface in 4428, but at an area 0.005 to 0.010 in. in from the notch. Here, elongated dimples point to lower right (toward center of notch). The black line indicates a sudden change in surface level.

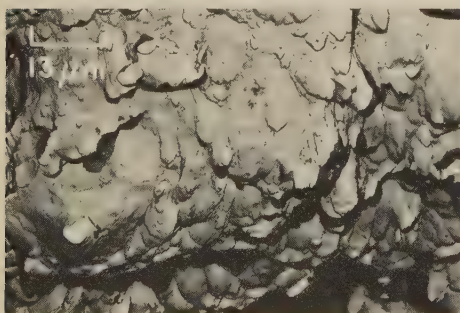
TEM fractograph (direct carbon replica) $750\times$

4430 TEM replica of the fracture surface in 4428, showing an area the same distance from the notch as the area in 4429 but nearer the surface of the wire. Here, the dimples point downward (toward the notch). The black bands denote sharp changes in surface level.

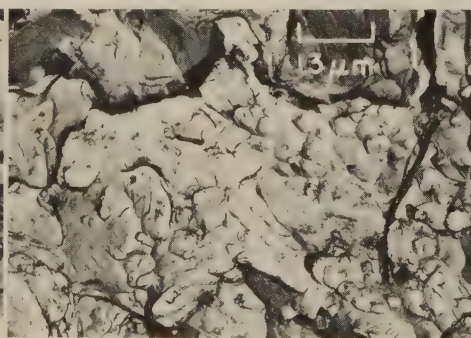
TEM fractograph (direct carbon replica) $750\times$

4431 TEM replica of the fracture surface in 4428, showing an area about three times as far from the notch as the areas in 4429 and 4430. Equiaxed dimples are evident at top, bottom and right, but cleavage is present also (at center).

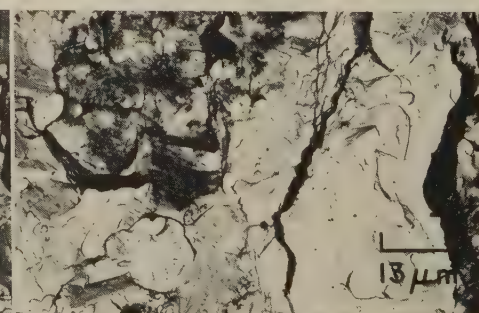
TEM fractograph (direct carbon replica) $750\times$

4432 TEM replica of the fracture surface in 4428, showing an area in the fast-fracture region, about five times as far from the notch as the areas in 4429 and 4430. The features here have resulted largely from cleavage, but small groups of dimples are in evidence also.

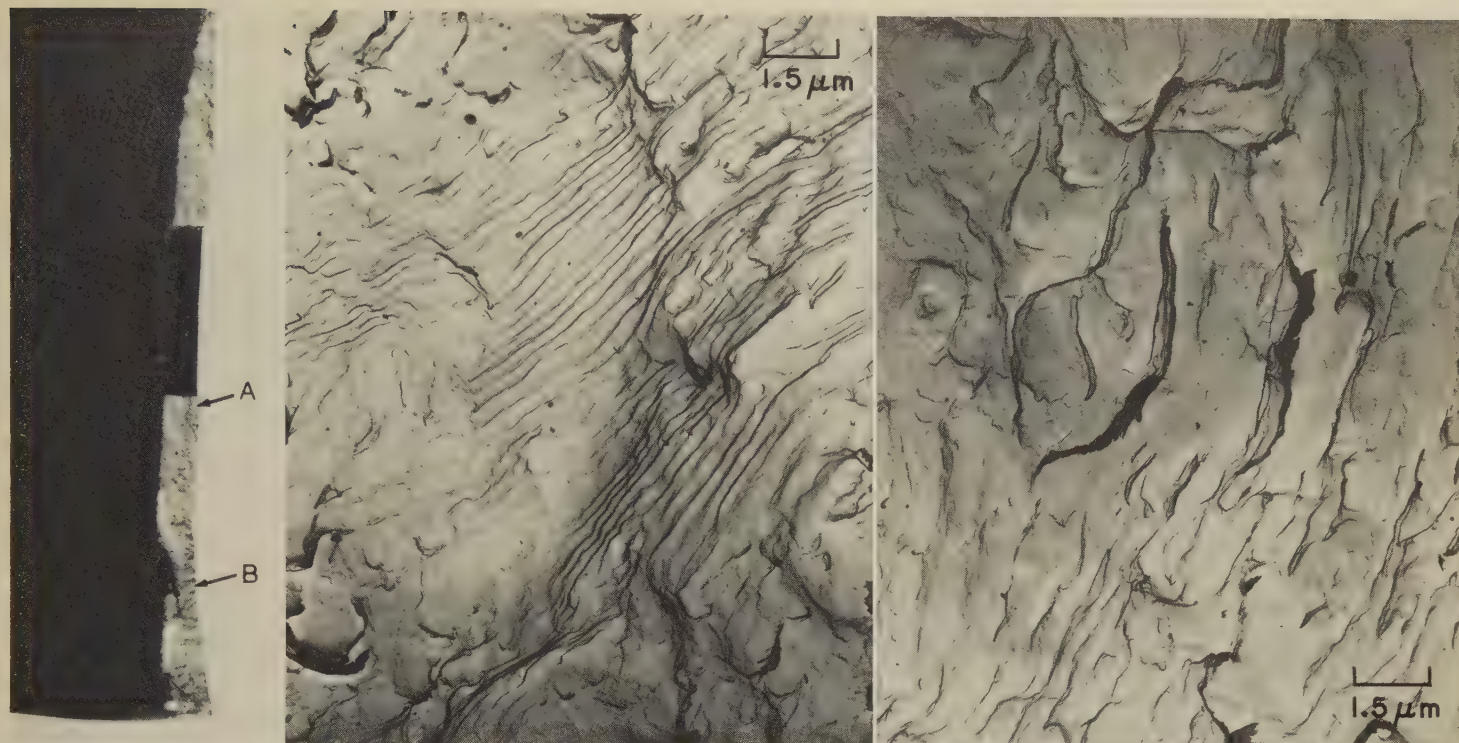
Light fractograph 4½× TEM fractograph (p-c replica) 6500× TEM fractograph (p-c replica) 6500×
4433, 4434, 4435 Fractograph 4433 (left) shows the surface of a high-cycle fatigue fracture in a 5½-in. by 1-in. by 0.050-in. notched specimen of type 431 stainless steel oil quenched from 1038 C (1900 F) and tempered at 274 C (525 F) to a tensile strength of 1241 to 1379 MPa (180 to 200 ksi). The notch consisted of a center hole 0.01 in. in radius and 0.2 in. long. The specimen was subjected to tensile stress that was cycled from 154.4 to 772 MPa (22.4 to 112 ksi) at 1000 cycles per minute, and fracture occurred after 5700 cycles. Fractographs 4434 (center) and 4435 (right) are TEM replicas of two areas at A in 4433, immediately below the notch. In 4434, fatigue striations are well developed, and suggestions of partly formed dimples are present at a few locations. In 4435, fatigue striations are much less regular than in 4434; again, there are suggestions of partly formed dimples. See also 4436 to 4438, below.

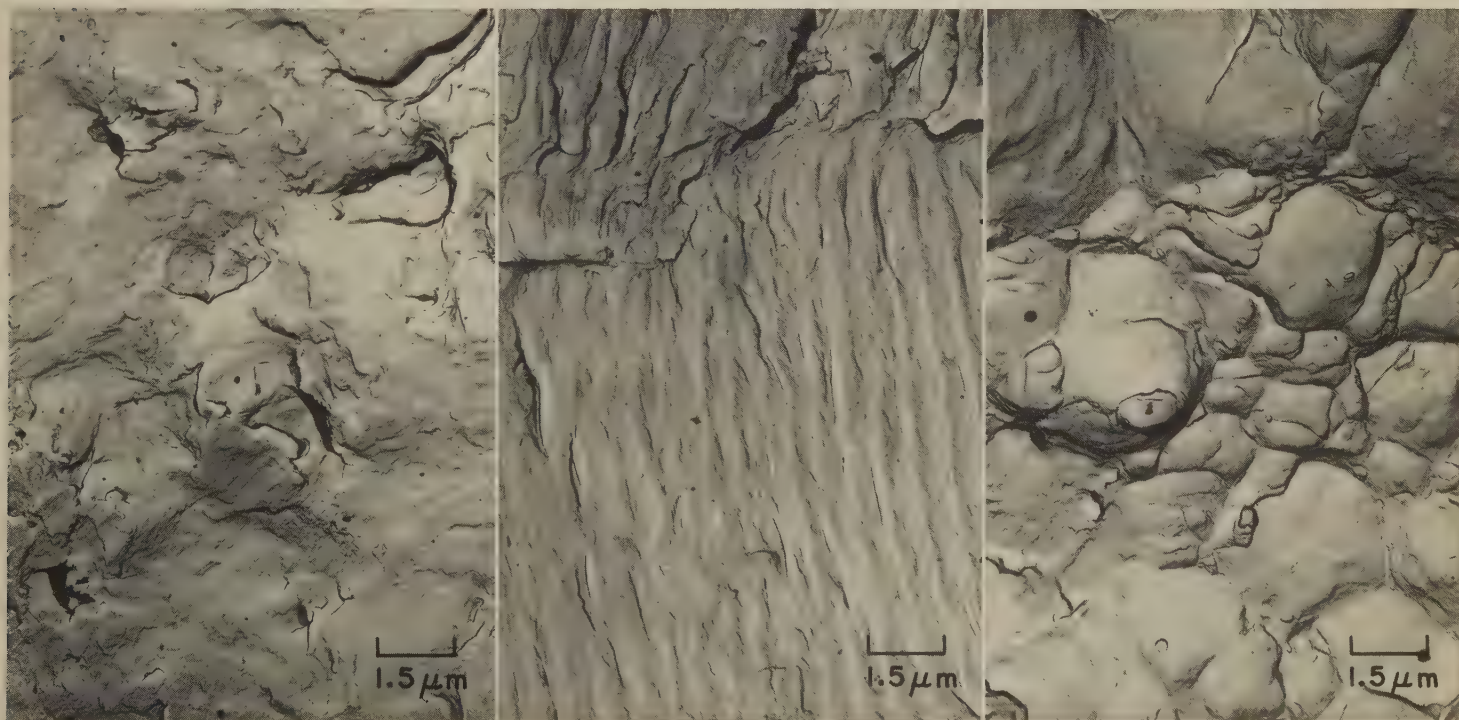
TEM fractograph (p-c replica) 6500× TEM fractograph (p-c replica) 6500× TEM fractograph (p-c replica) 6500×
4436 TEM replica of a third area at A in 4433. This area exhibits faint but quite recognizable fatigue striations with spacings similar to those in 4434.
4437 TEM replica of a fourth area at A in 4433. Regular, widely spaced fatigue striations resulted from increased stress due to reduced cross-sectional area.
4438 TEM replica of an area at B in 4433. The equiaxed dimples visible here resulted from tension overload during final fracture but before final shear rupture.

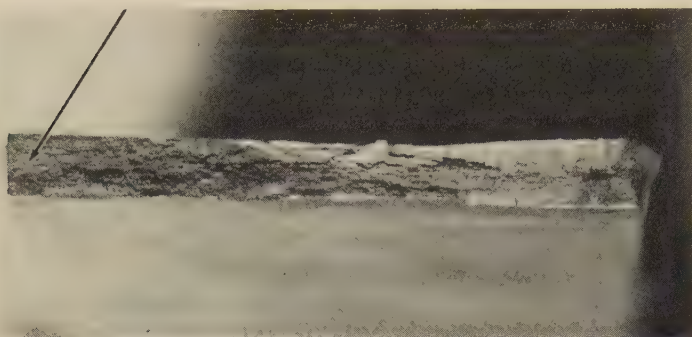
4439, 4440

Light fractograph

At left (4439) is a stress-corrosion fracture in a sheet specimen (1½-in. by 0.25-in. by 0.025-in. gage section) of type 633 (AM-350) precipitation-hardenable stainless steel solution treated at 932 C (1710 F) and aged at -73 C (-100 F) to a tensile strength of 1448 MPa (210 ksi). Fracture occurred after exposure to marine air under stress of 593.7 MPa (86.1 ksi) for 16 days, originating at one edge of the specimen. Fractograph 4440 (at right) is a TEM view of an area at arrow in 4439. This area is the region of flat, fine-textured fracture produced by stress-corrosion cracking before fracture terminated by shear at the other edge. The fracture surface here is intergranular and contains a moderate amount of corrosion products. See 4441 and 4442.

6×

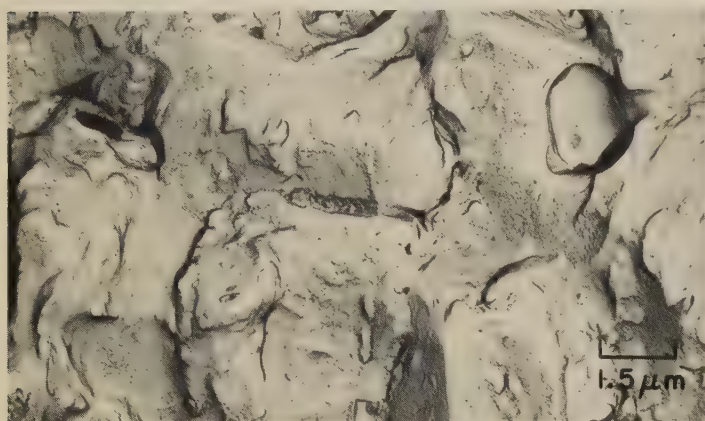
4441

TEM fractograph (p-c replica)

6500×

A TEM view of a second area at the arrow in fractograph 4439. This area, like that in 4440, displays an intergranular surface containing only moderate amounts of corrosion products. A dimple is evident at top right, and features elsewhere suggest very small, embryonic dimples. See also 4442.

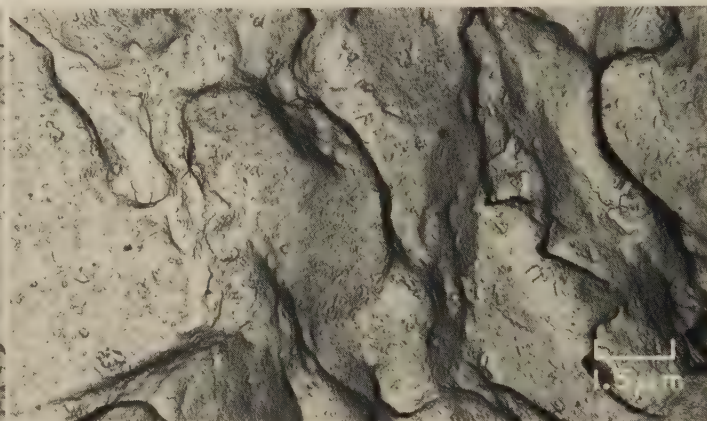
4442

TEM fractograph (p-c replica)

6500×

A TEM view of a third area at the arrow in fractograph 4439. Like the areas shown in 4440 and 4441, the one here exhibits an intergranular fracture surface. In this area, however, there appear to be several secondary cracks following grain boundaries between the fracture facets.
